SALT LAKE CITY STREAMS, UTAH

LITTLE DELL LAKE
FOUNDATION REPORT

APRIL 1995

U.S. ARMY CORPS OF ENGINEERS
SACRAMENTO DISTRICT
SACRAMENTO, CALIFORNIA

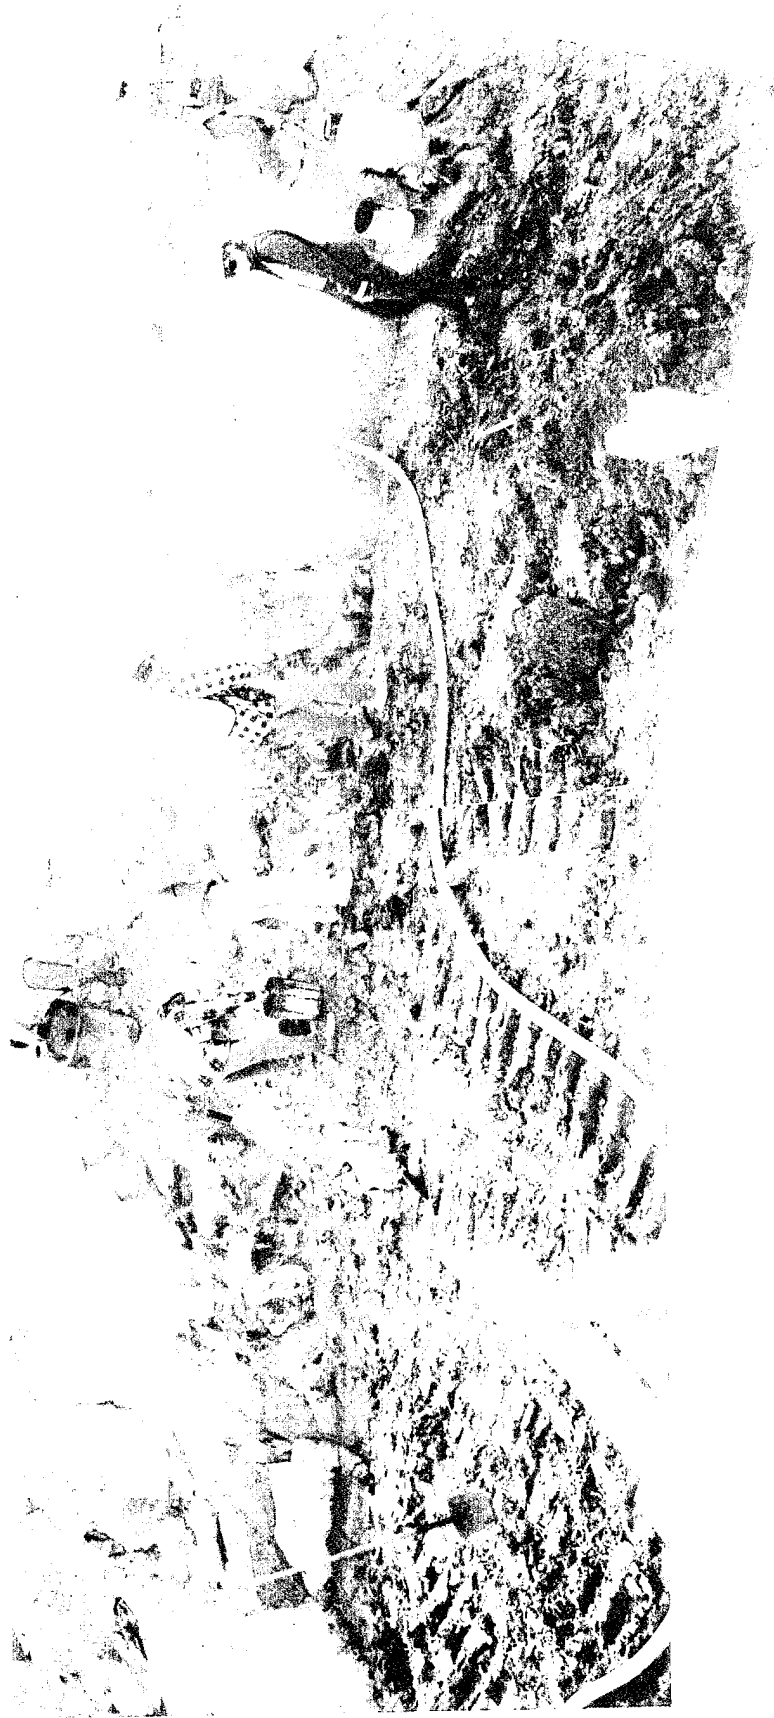
PHOTO CT24. Looking left at the same area as the previous photo. Crew is working on mortaring joints marked with green paint.

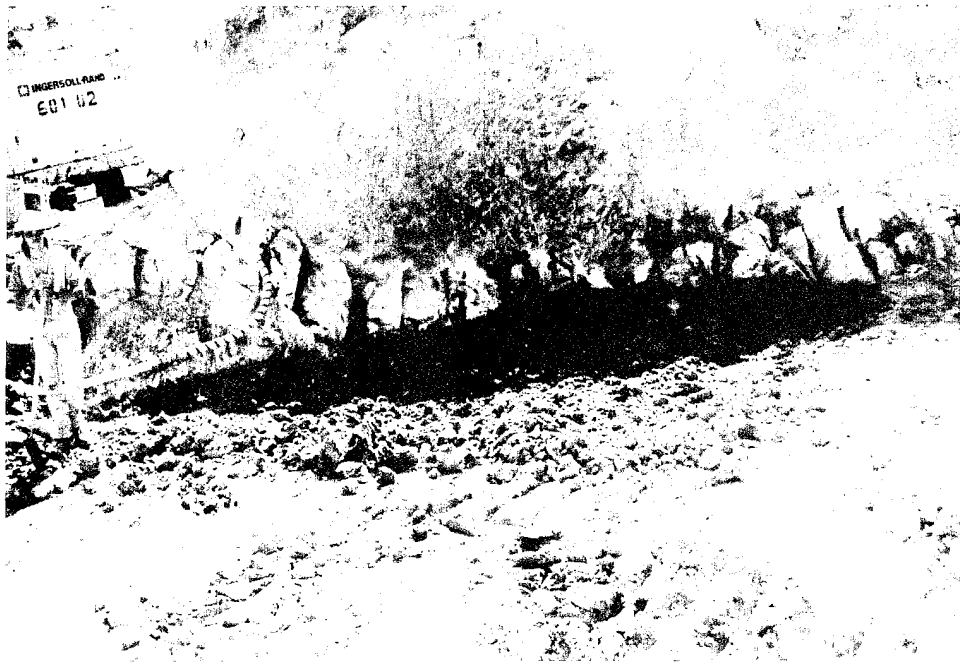
PHOTO CT29. More distant view of the area in the previous photo.

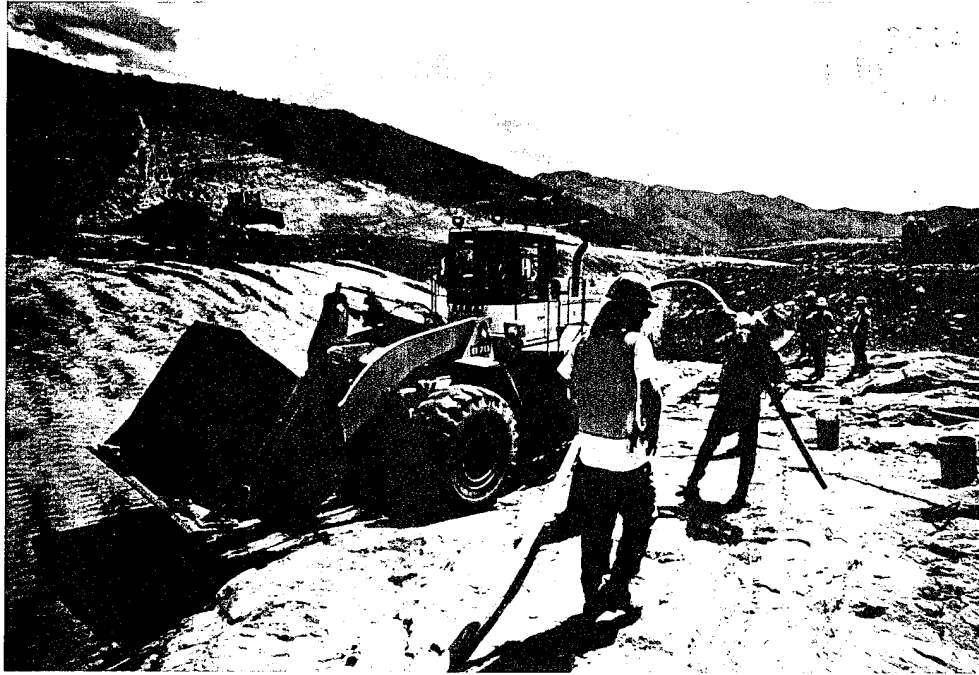
PHOTO CT30. Looking downstream near Sta. 18+00 in the core trench. Crew completes final preparation of foundation in an area where little or no joint mortaring was required (see also the Foundation Treatment Map). The Mesco front-end loader is performing wheel rolling of impervious fill against a previously approved area to the left.

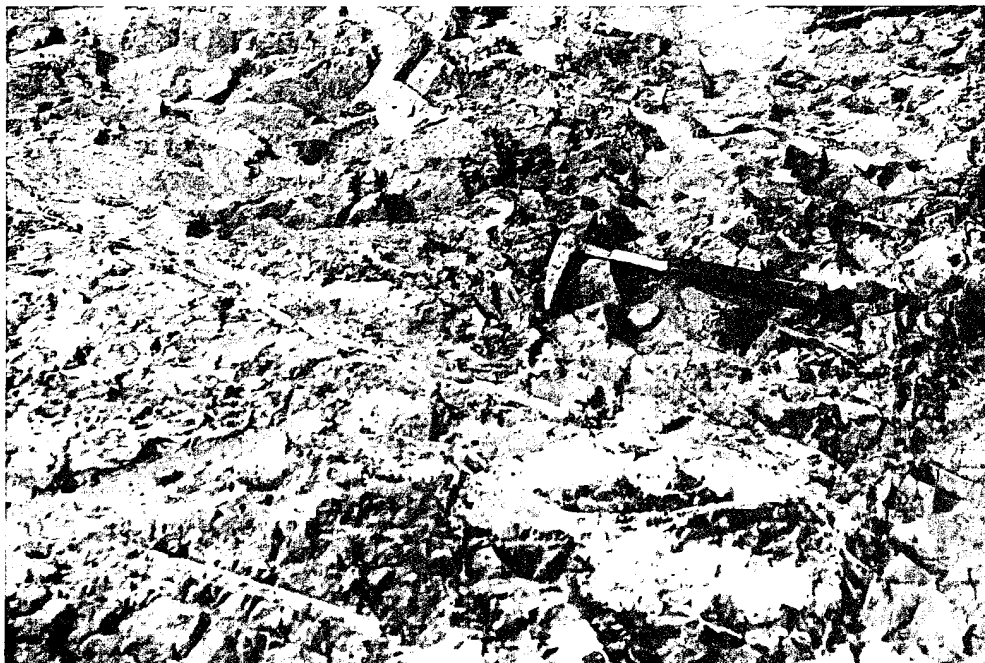
PHOTO CT31. Looking upstream from the grout curtain (15 feet upstream of the dam axis) at an area near Sta. 21+60. Gray stringers are grout filled fractures. Excessive pressure was apparently used at this location, resulting in some lifting of the foundation. The fractures were filled with dense grout and no harmful effects resulted. This photo shows an area typical of the conditions where the soft rock was intensely fractured, but the fractures were tight and no joint mortaring was required.

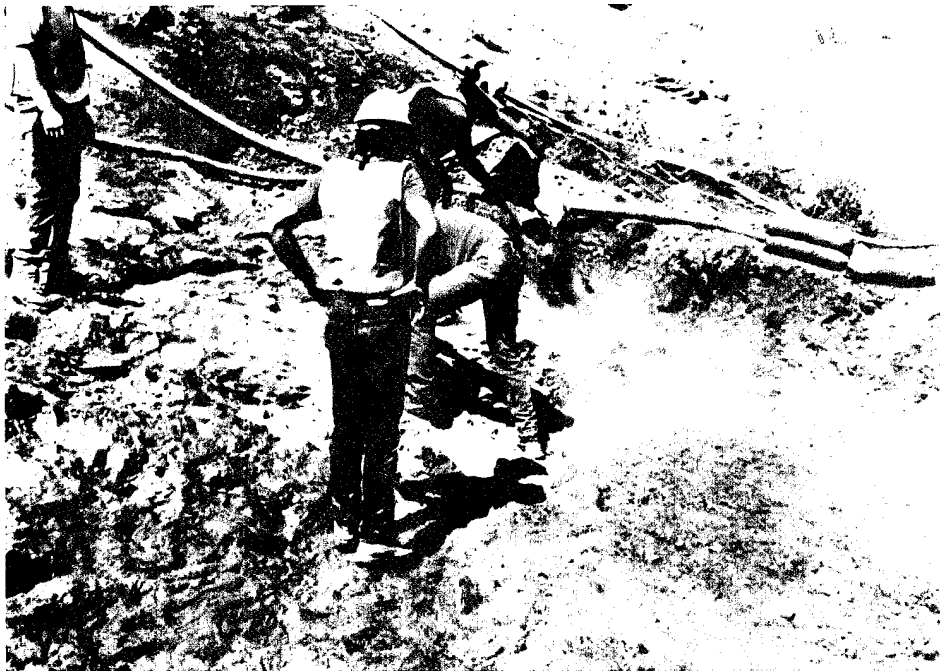
PHOTO CT32. Looking upstream at an area of the core trench foundation near the toe of the upstream cutslope, Sta. 22+05. The crew is spreading dry cement on area of numerous small seeps immediately before placing impervious fill.

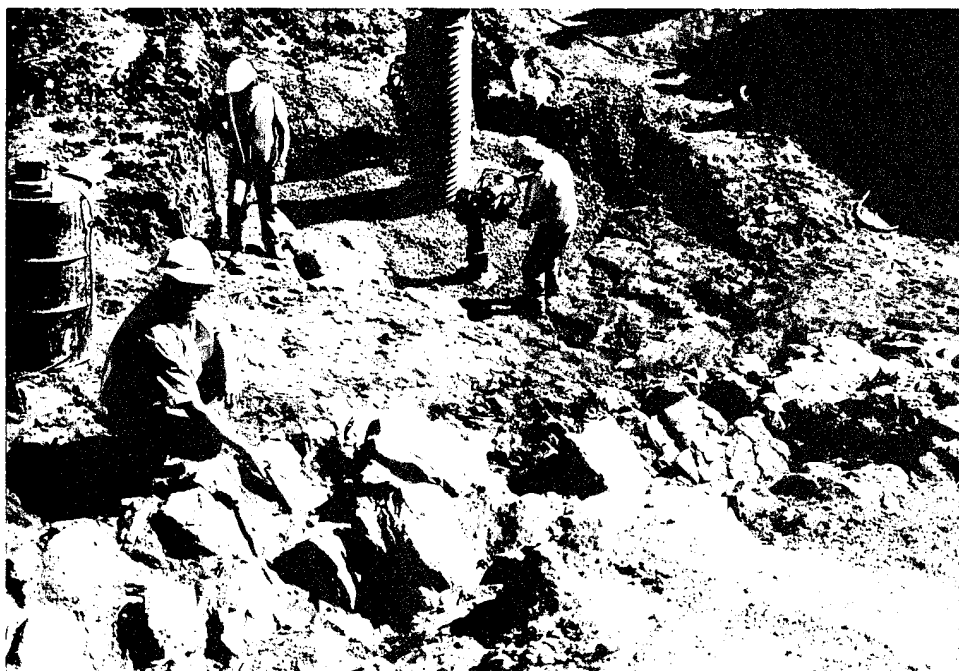
PHOTO CT34. Looking left from about Sta. 23+60. Howie Aubertin, Corps of Engineers Assistant Resident Engineer, with rock hammer pointing to substantial flow from a spring which flows down to the sump below. A worker is using hand operated equipment to compact the gravel in the sump.

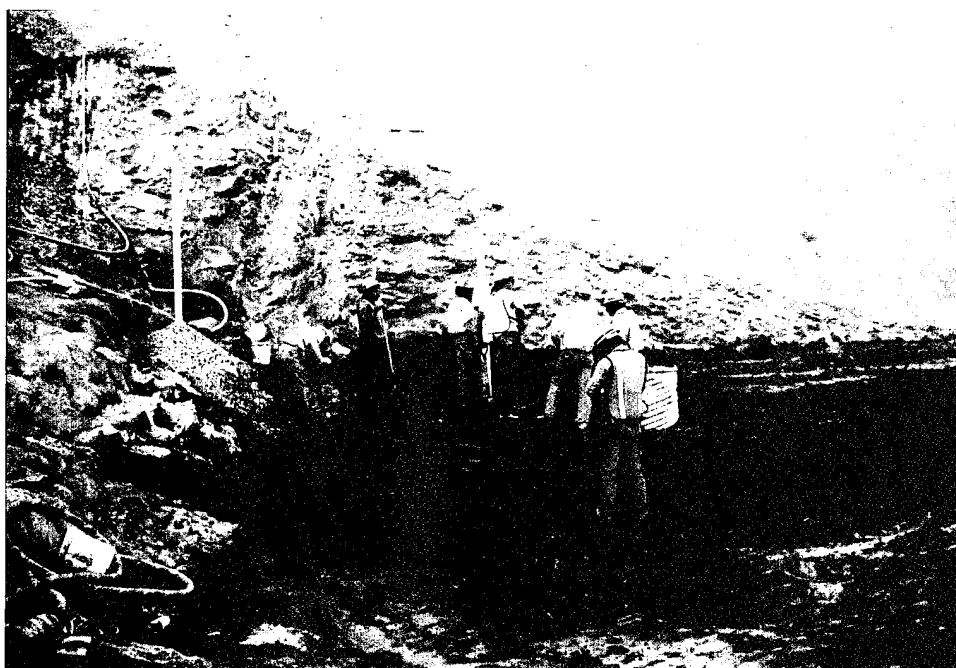
PHOTO CT35. Looking upstream along Sta. 23+50 at sump. Note the 24-inch-diameter CMP and two 4-inch diameter PVC pipes installed to facilitate grouting the sump later. Also note the gravel collector extending up to the spring shown in the previous photo.

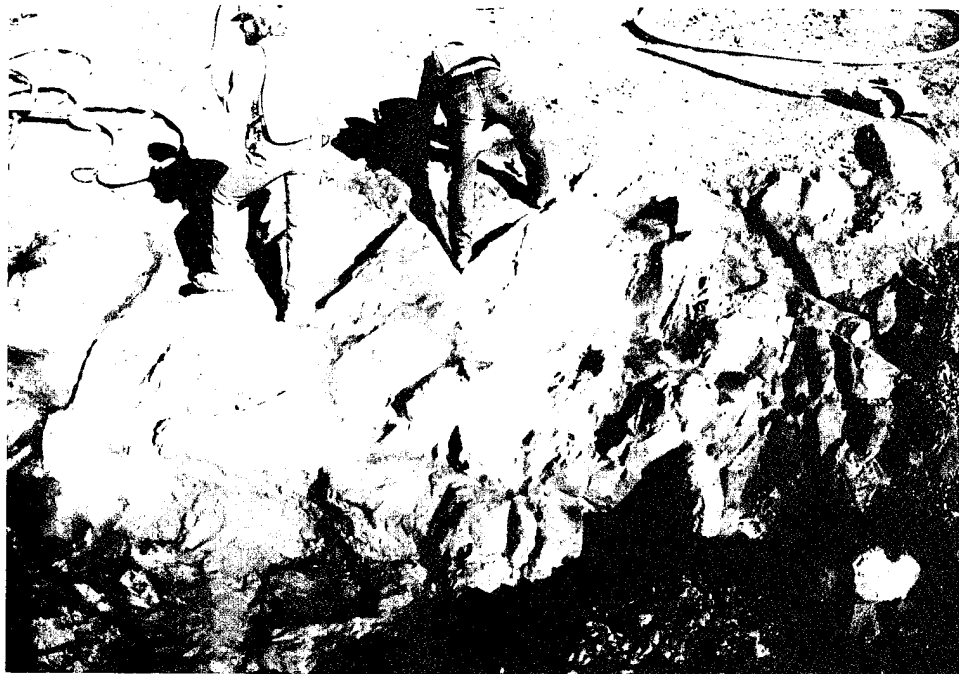
PHOTO CT36. Area below the feet of the workers where a limited amount of slush grout was utilized. Area extends upstream from the dam axis at Sta. 23+50.

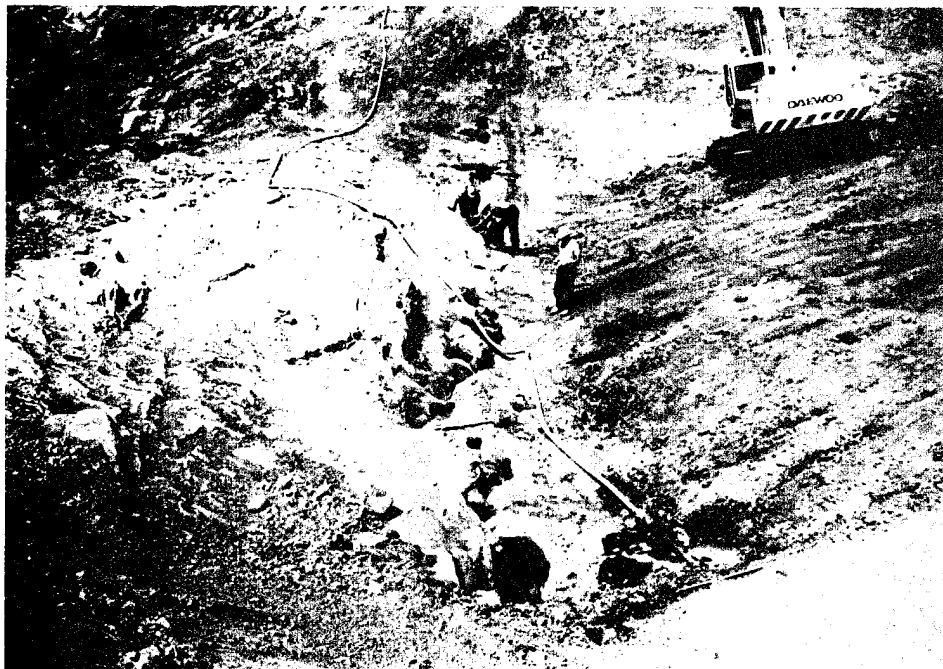
**PHOTO CT38.** Looking upstream at excavation of anomalous soft zones within hard sandstone bed crossing the dam axis between Sta. 20+05 and 20+15.

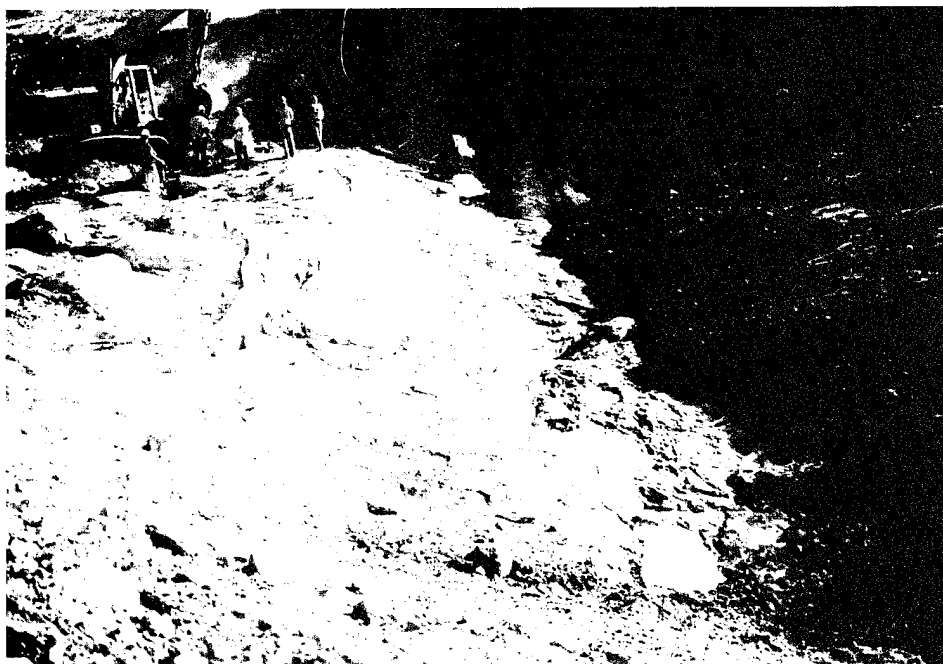
**PHOTO CT39.** Same area as the previous photo after placing dental concrete in the holes created by excavating the soft material.

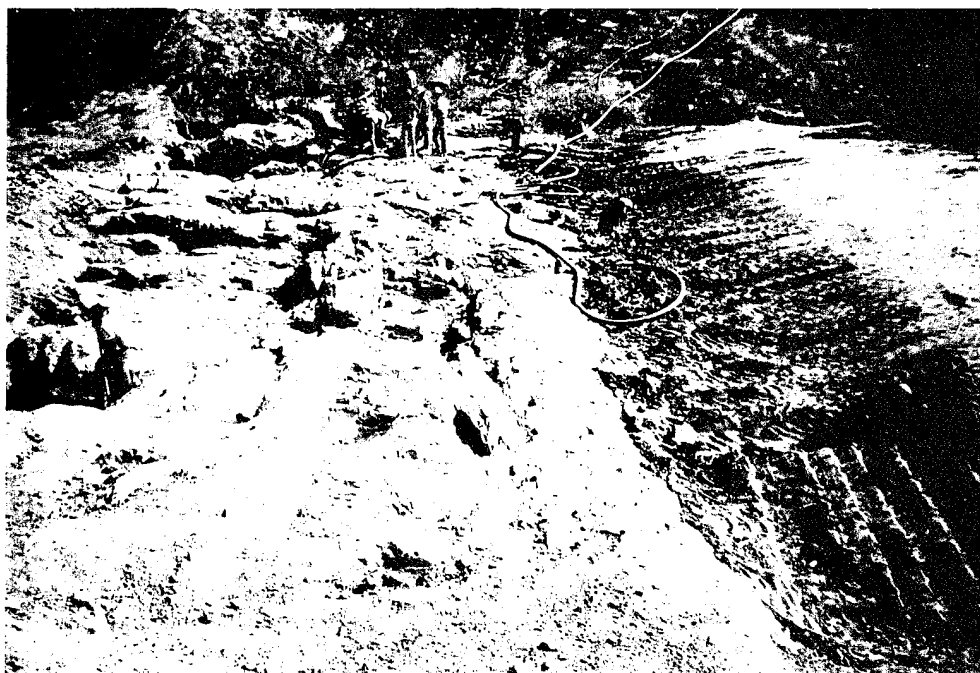
PHOTO CT40. Anomalous soft zone at left edge of the photo in a hard blocky sandstone layer at the downstream edge of the impervious core foundation near Sta. 20+70. The soft material was hand excavated and replaced with concrete.

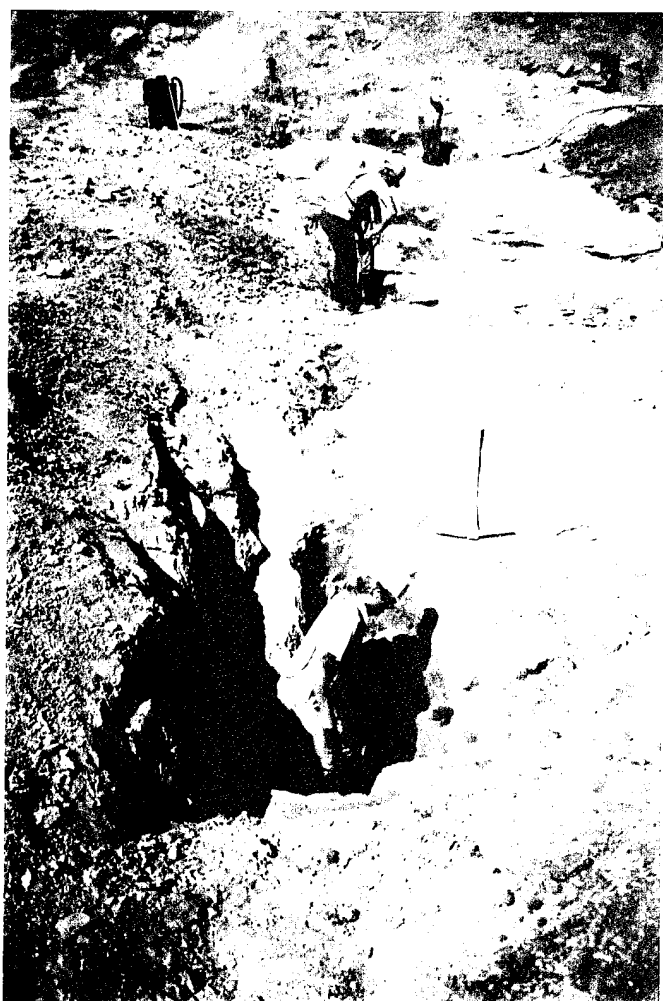
PHOTO CT41. Anomalous soft zone in a hard blocky sandstone layer at the downstream edge of the impervious core foundation near Sta. 20+70. The soft material was excavated and replaced with concrete.

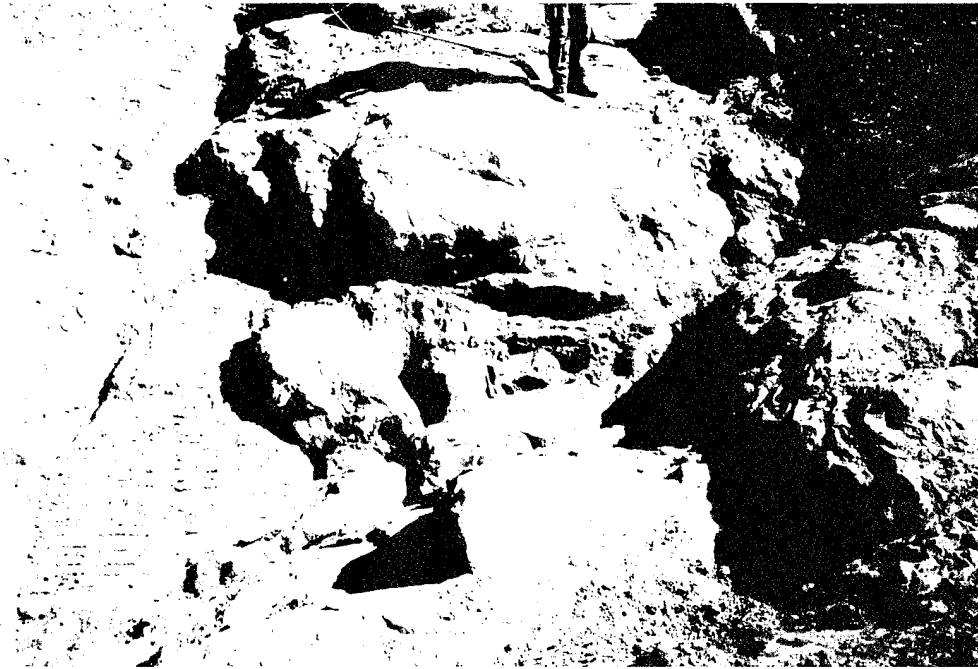
**PHOTO CT42.** Anomalous soft zone in hard blocky sandstone layer at the downstream edge of the impervious core foundation near Sta. 20+70. The soft material was hand excavated and replaced with concrete.

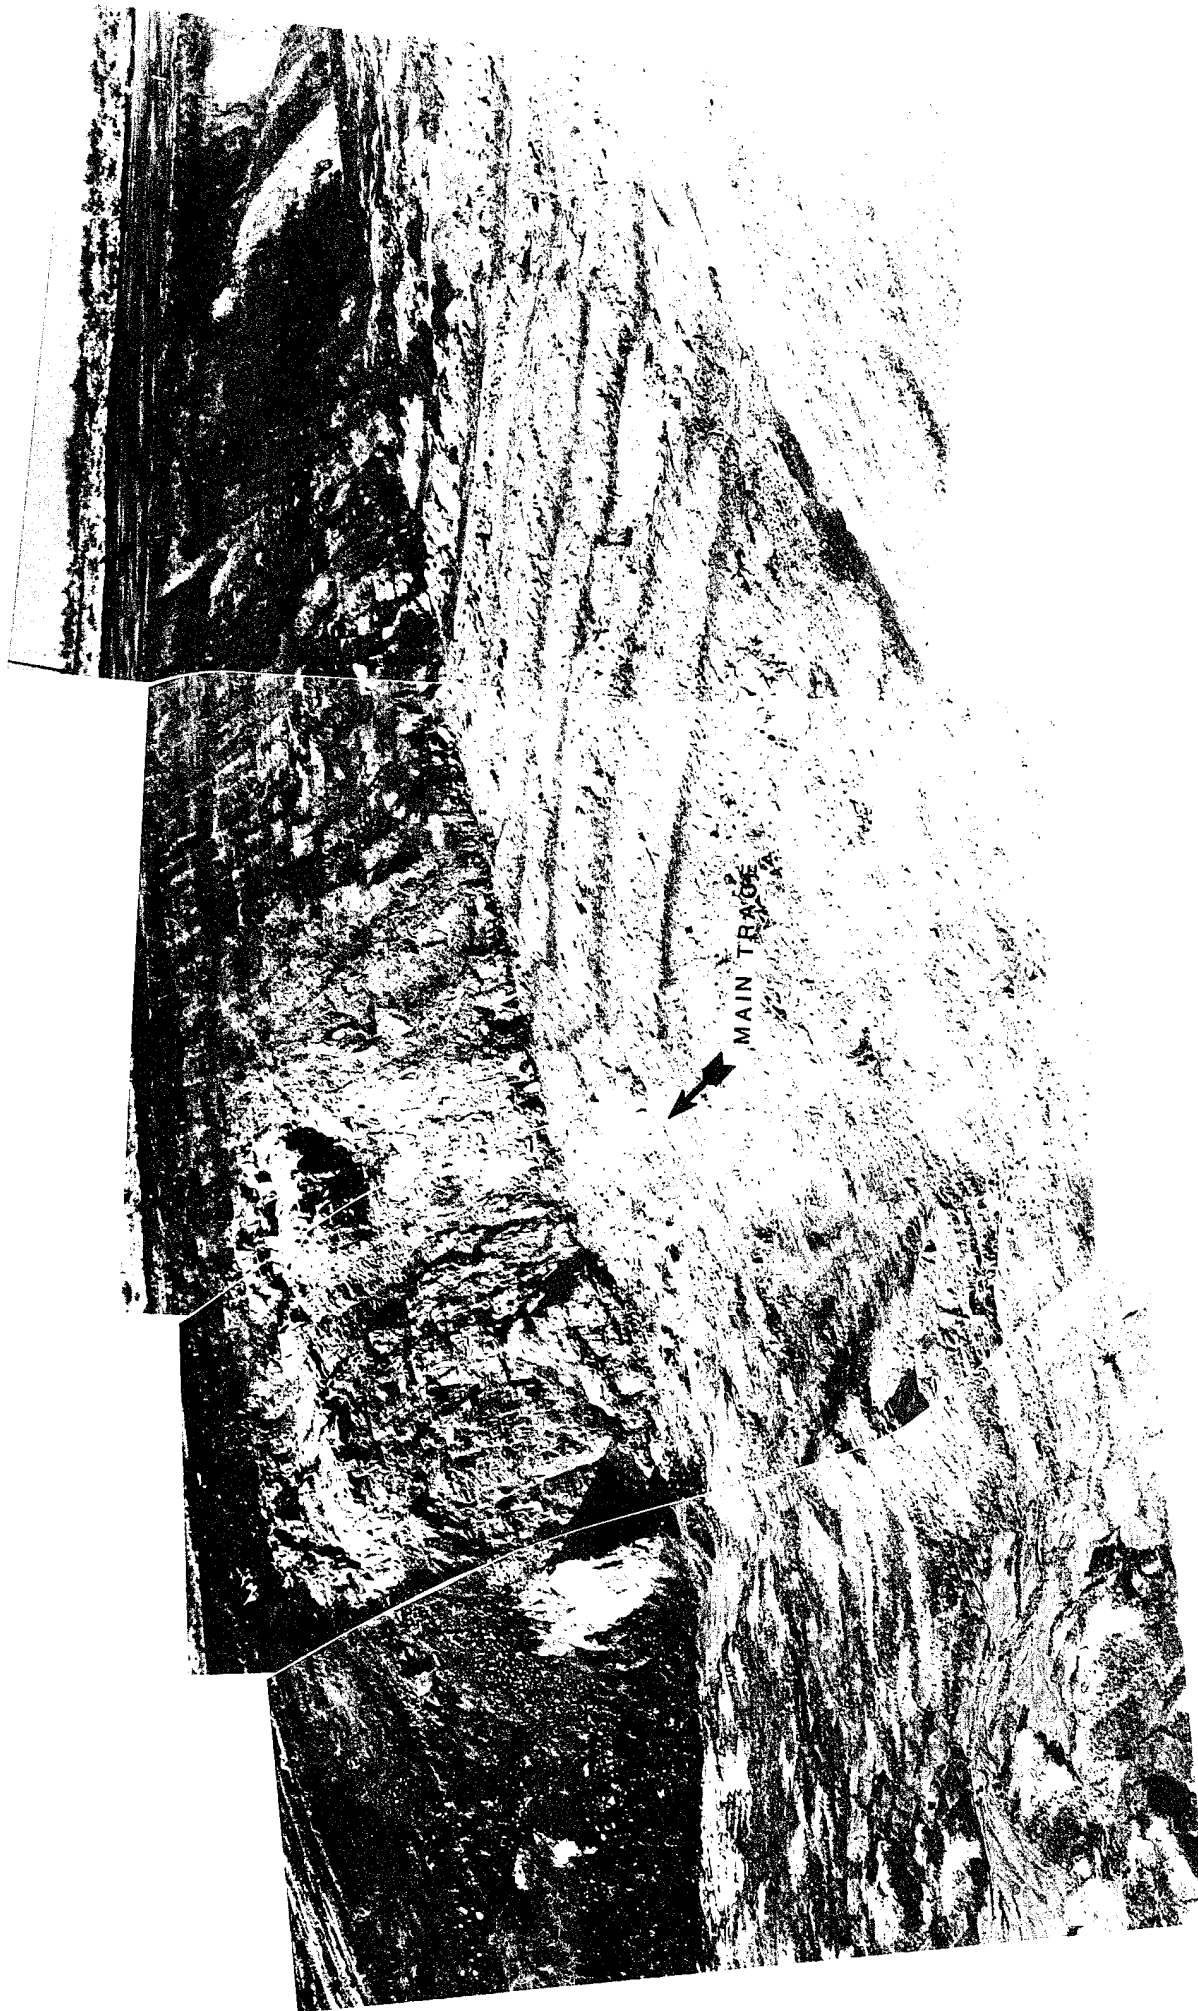
PHOTO CT46. Looking downstream from the top of the downstream  
cutslope at the Station 22 Fault Zone.

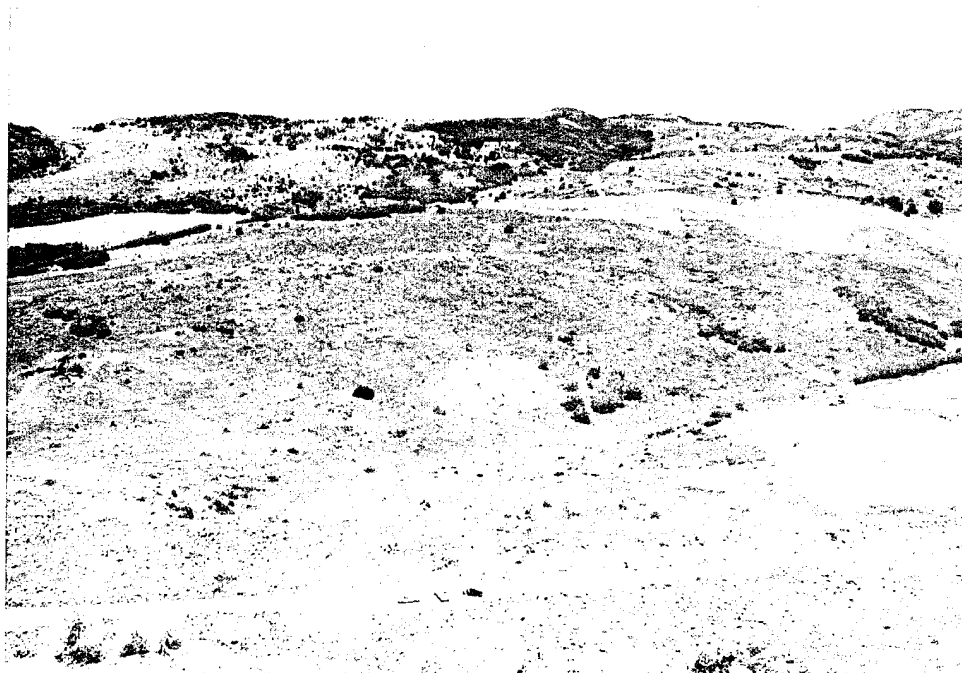
PHOTO EMB1 (Embankment Foundation 1). View of the right abutment from the left abutment before beginning excavation of the core trench.

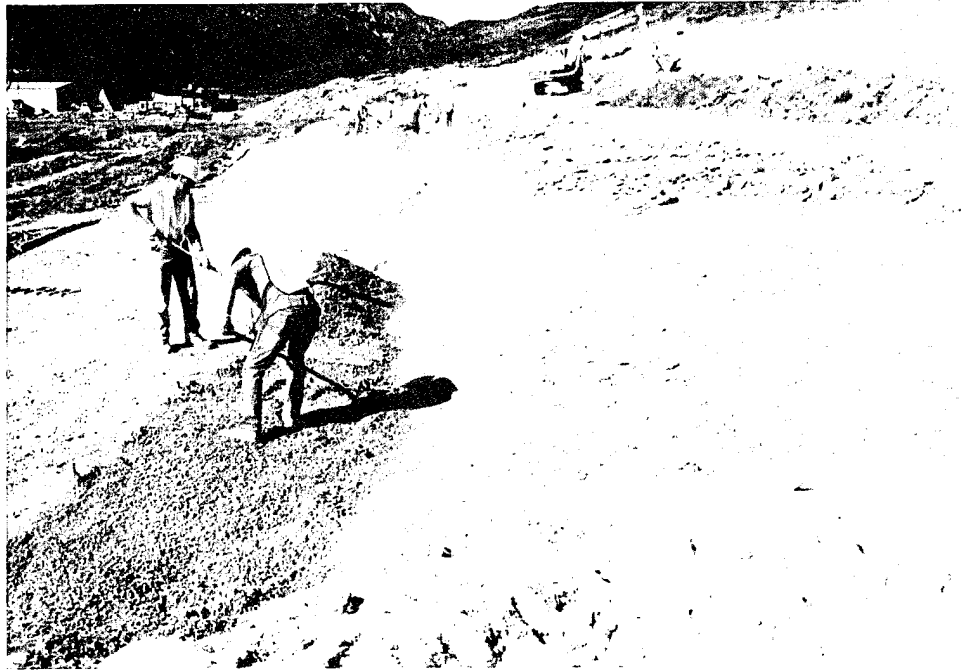
PHOTO EMB10. Looking downstream along the downstream right abutment as Transition 1 is placed on the area approved as "Area 051792b"

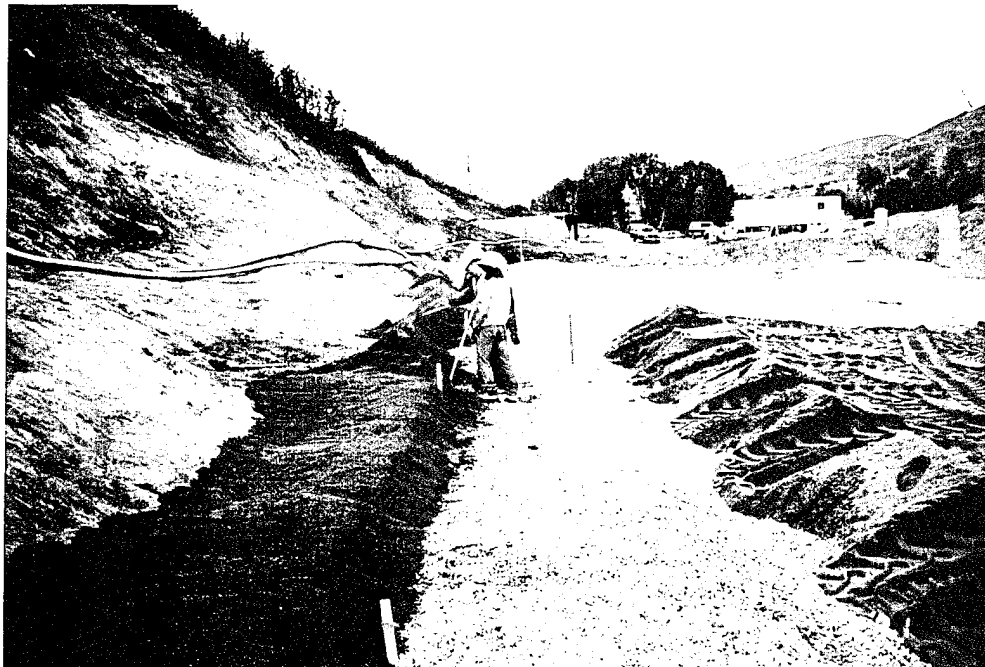
PHOTO EMB11. Looking downstream along the downstream left abutment as Transition 1 is placed on approved foundation.

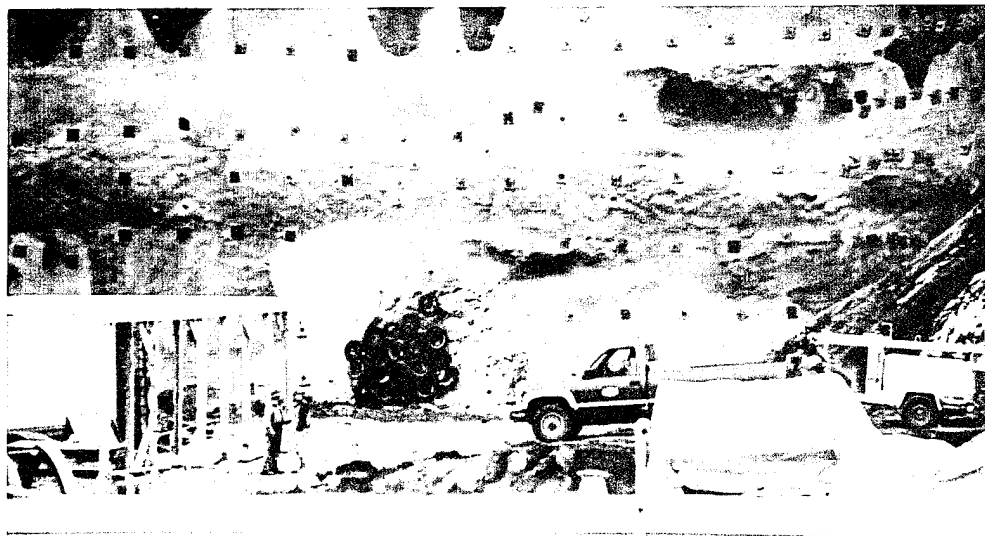
**PHOTO T1 (Tunnel 1).** Downstream portal of outlet works tunnel before blasting the first round. Blasting mat made of old tires was used to reduce "fly rock".

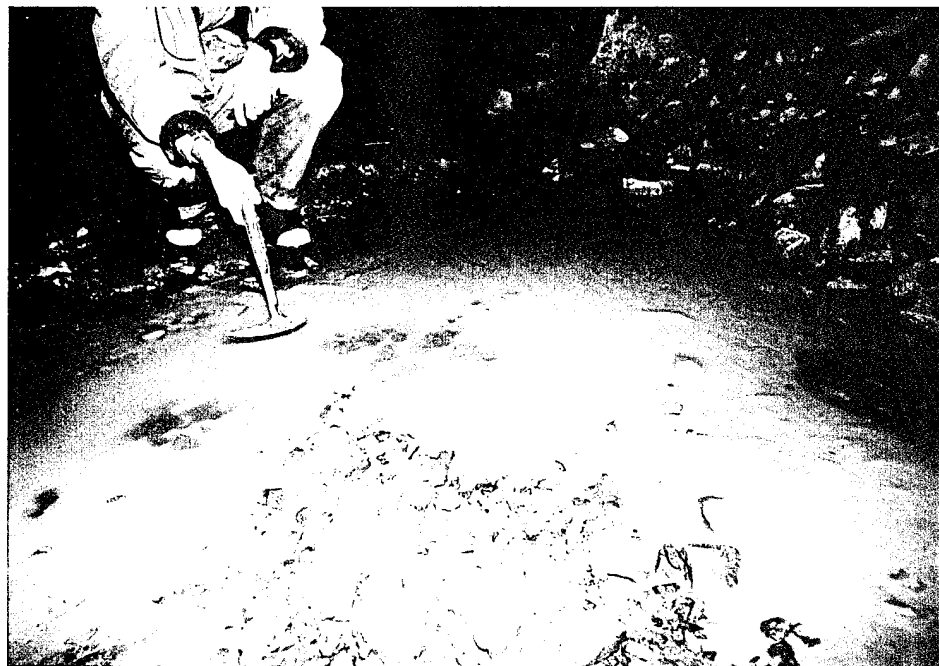
PHOTO T4. Dark areas are water seeping up from the invert near Sta. 22+98.

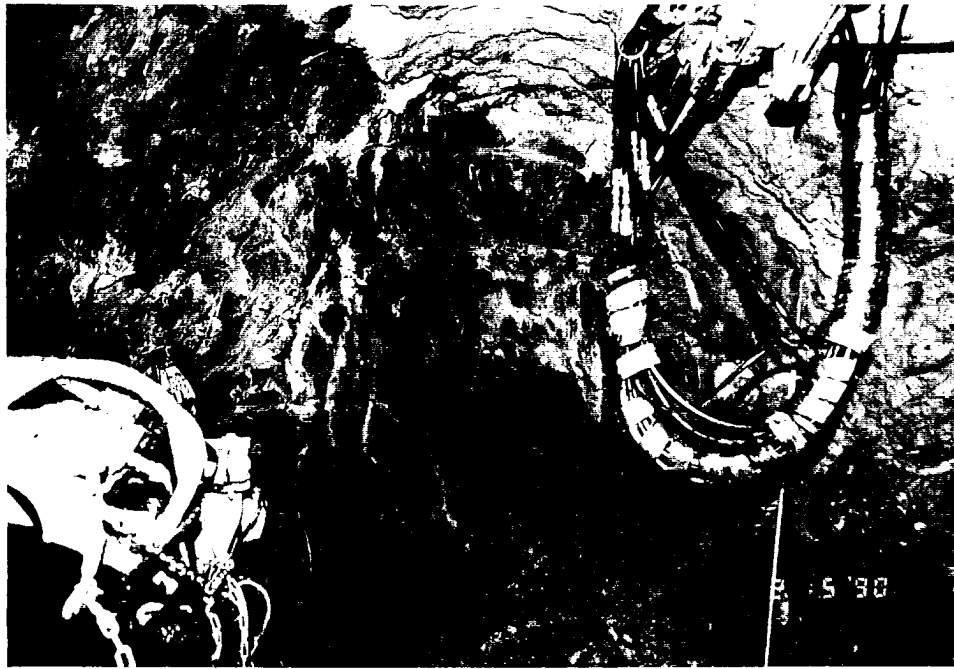
PHOTO T5. Looking upstream at area mapped as face No. 70 at Sta. 21+96. Montmorillonitic clay layer did not fragment properly when blasted, causing damage to several sets already in place.

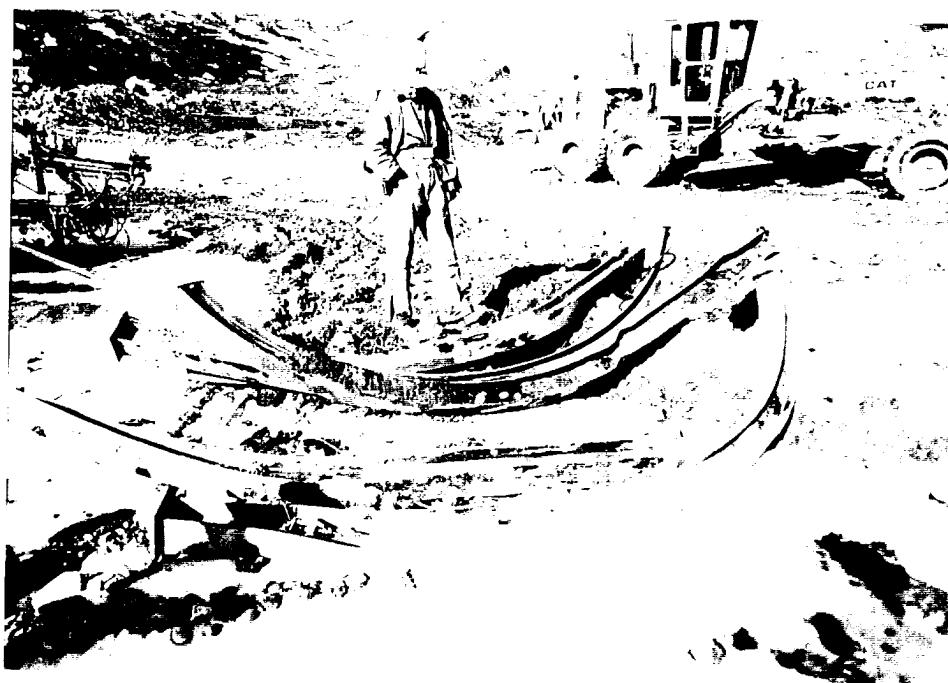
PHOTO T7. Damaged sets after being removed from tunnel.

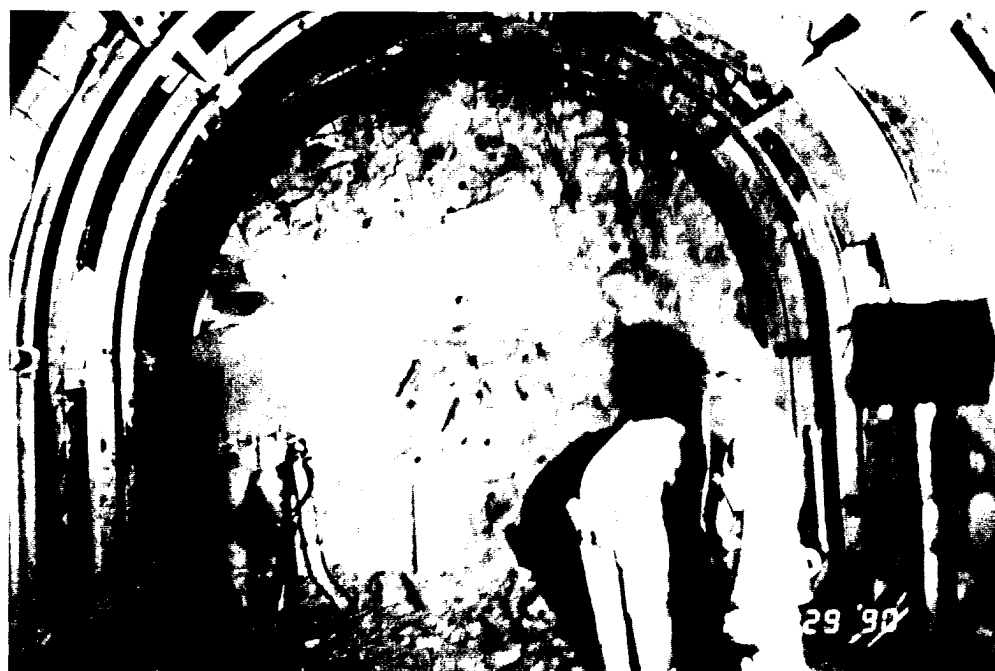
PHOTO T8. Pattern of blast holes drilled in heading.

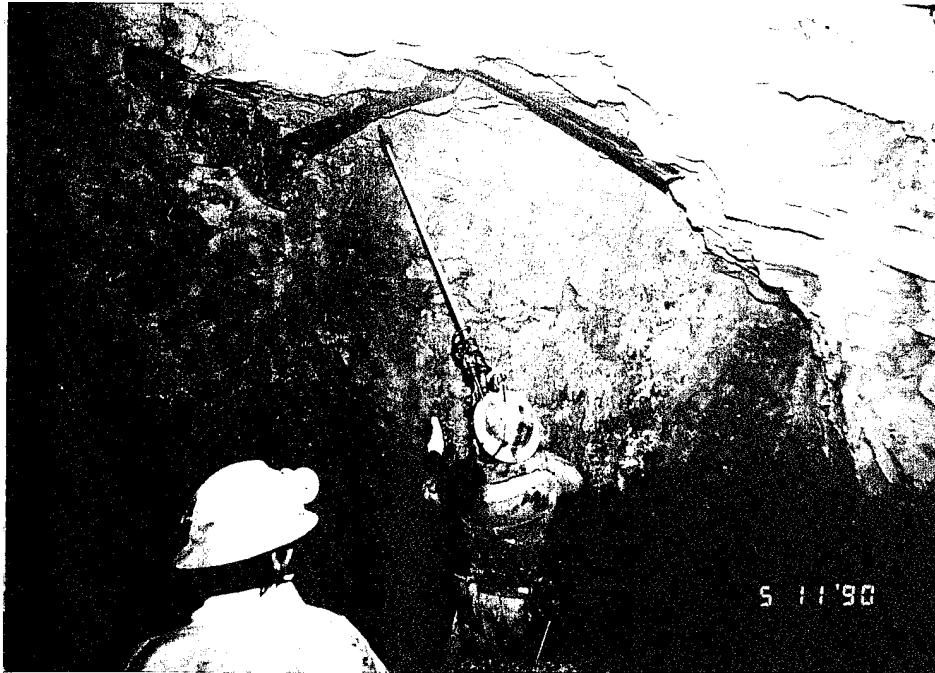
**PHOTO T9.** Using a jackleg drill to install a tunnel strap in the crown of the excavation at Sta. 11+70.

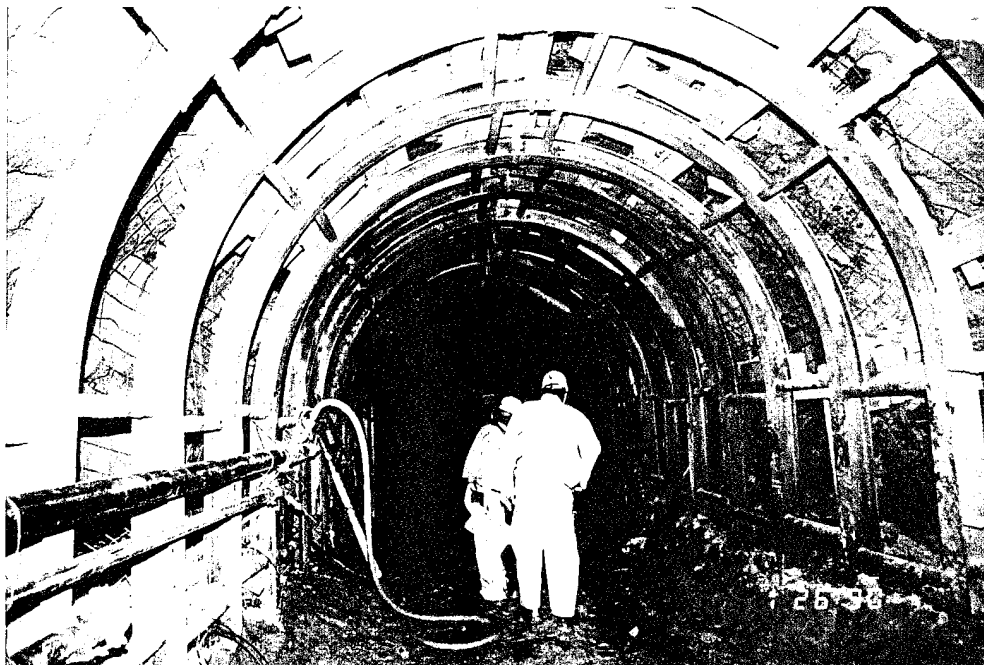
**PHOTO T10.** Looking upstream in the downstream adit. Tunnel sets, blocking and shotcrete were used as initial support. Shotcrete ends in the near view.

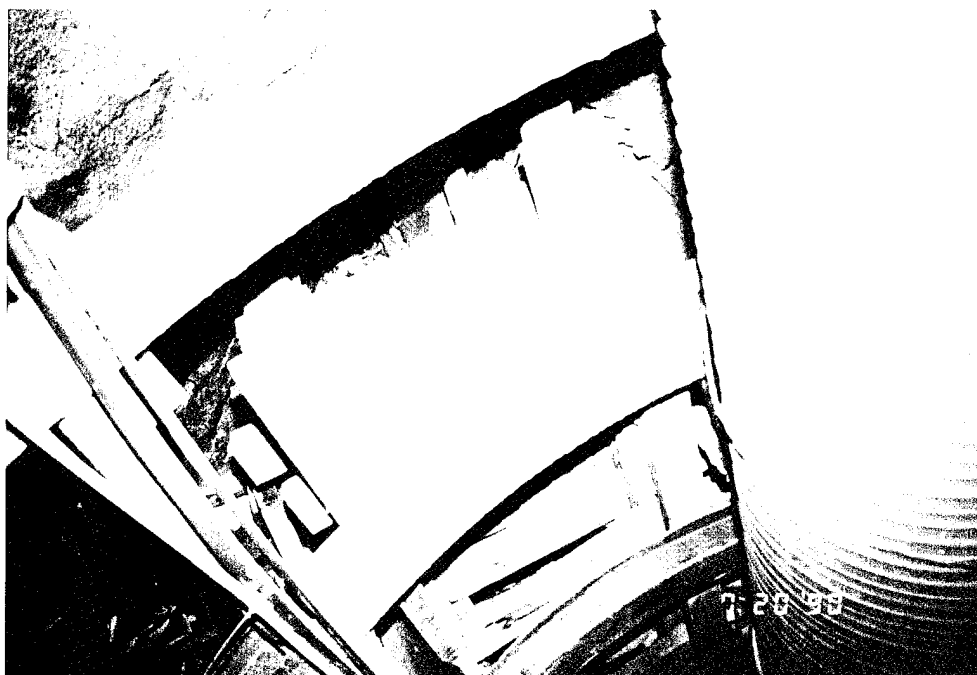
PHOTO T11. Woodblocking constructed in "log cabin" type configuration to allow concrete to flow around and between timbers.

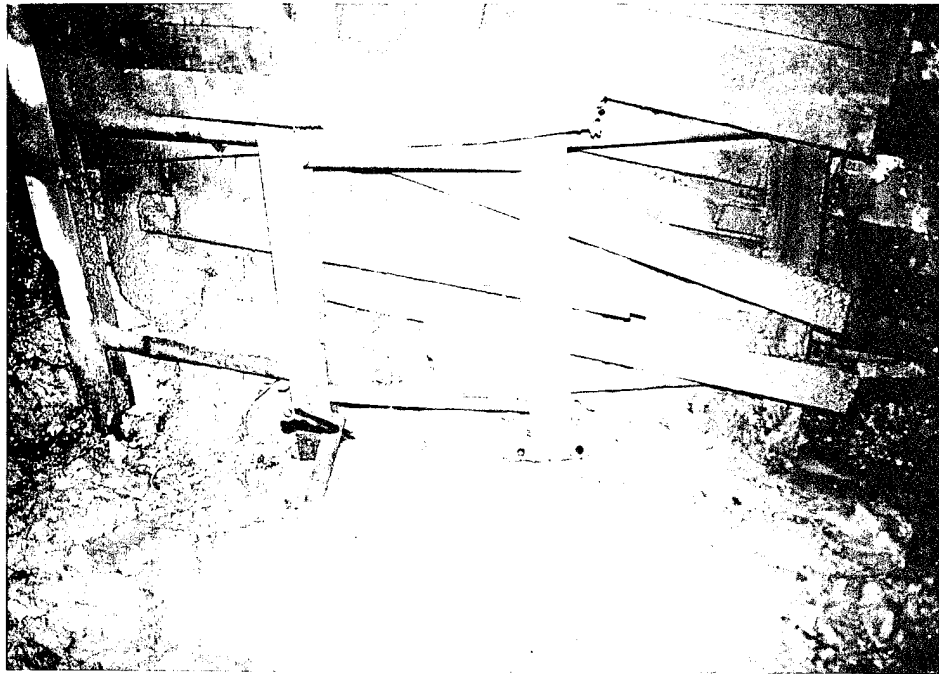
**PHOTO T15.** Same area as previous photos. Looking more directly at lower part of left side of tunnel. Yellow material at bottom of sets is fault gouge. Water flowing from fault was visually estimated at greater than 20 gpm.

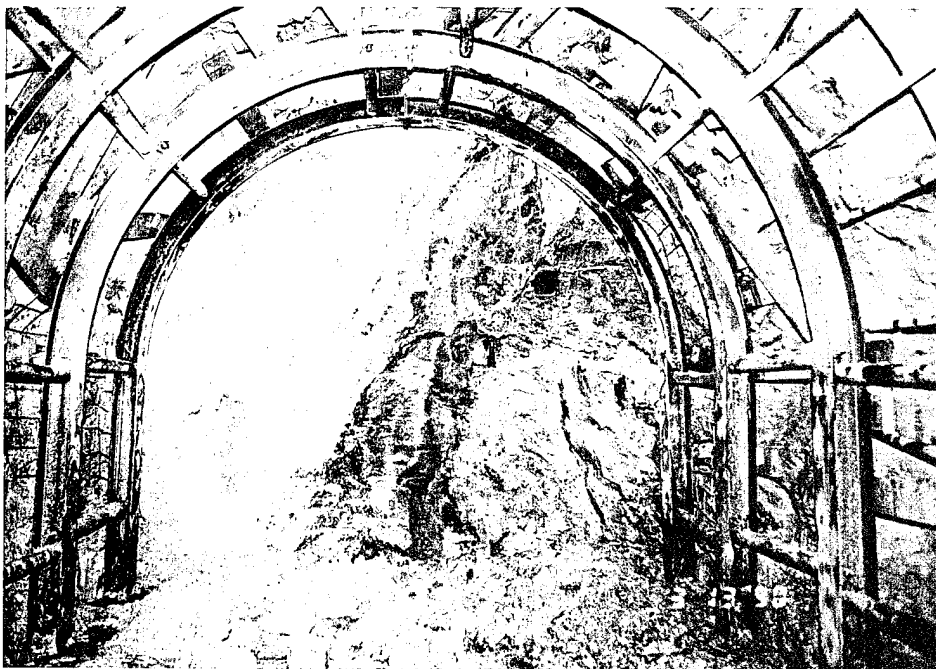
**PHOTO T16.** Looking upstream at the Set 263 Fault in heading at about Sta. 18+32. Yellow-brown clay gouge and breccia slope across the left side of the photo.

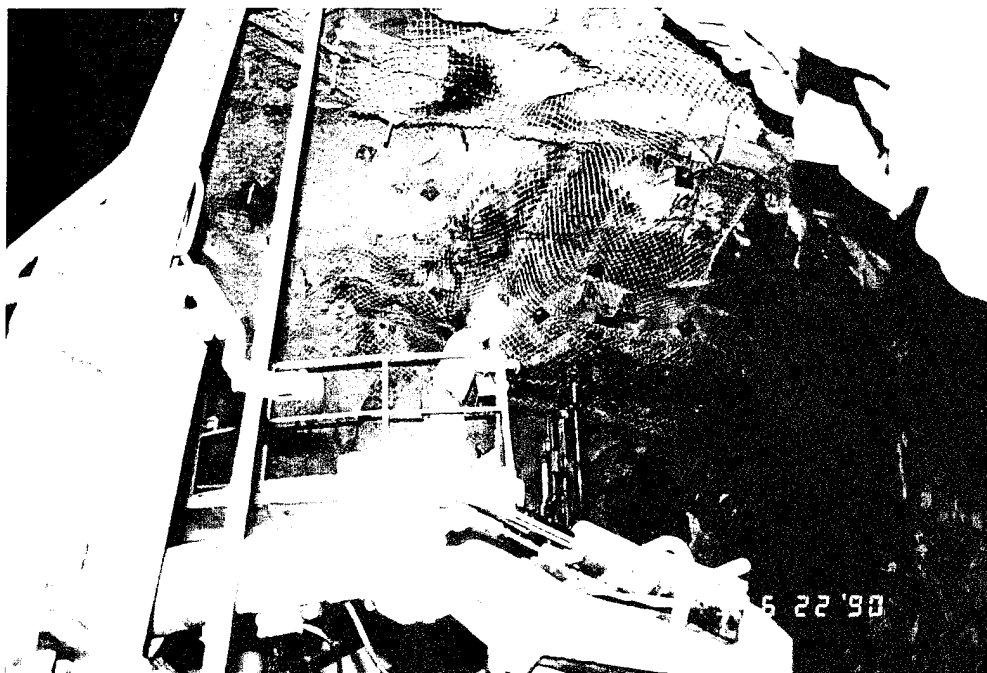
PHOTO T21. Looking right (northwest) at the anchor being installed.

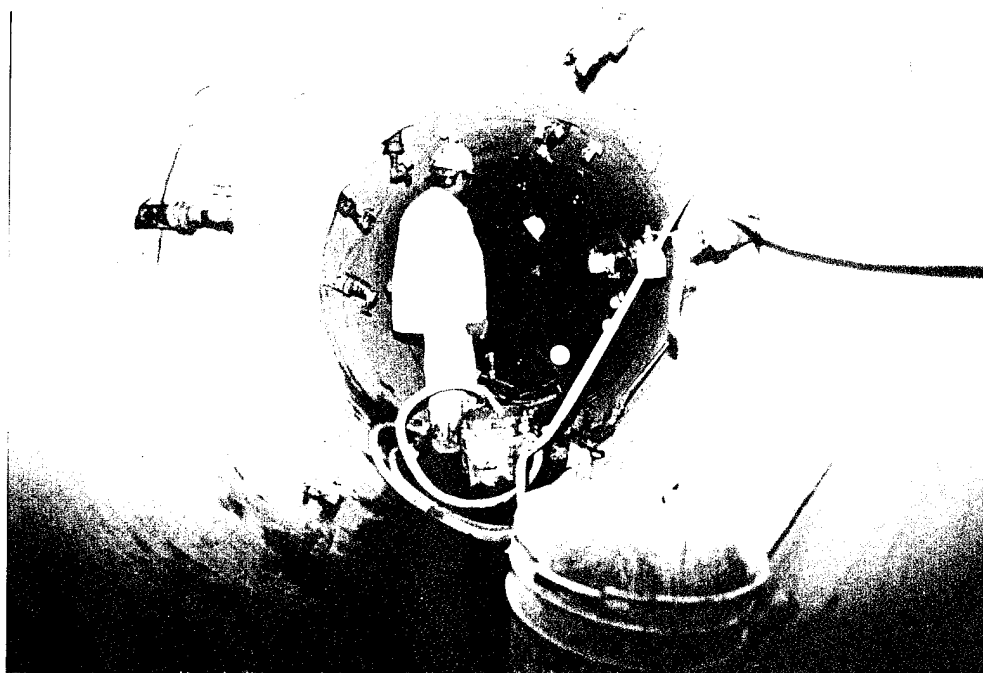
PHOTO T26. Grouting in progress in upstream tunnel.

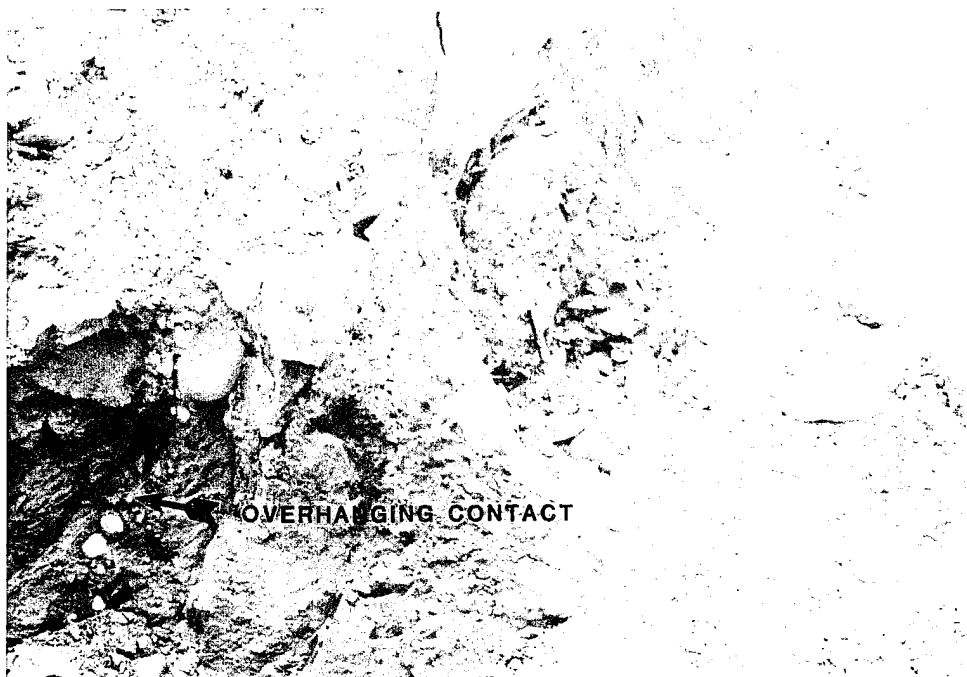
PHOTO GF2. View of the upper part of the south wall of fault trench FT-3. Gray sheared bedrock overhangs Older Alluvium.
